Manhole Inspection Summary

Manhole # S49GG_040MH

Insp Date: **8/7/08 9:38 AM**

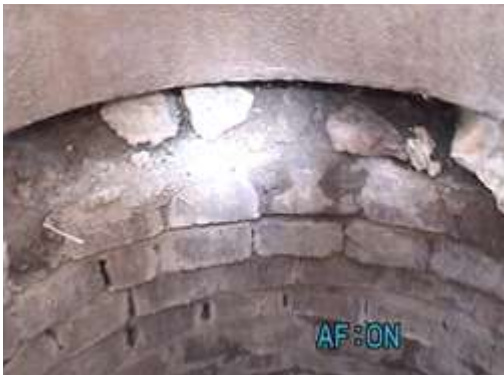
Defect 1

Condition: ☐ Sound ☐ Cracked ☐ Root Intrusion ☒ **Loose Brick** ☐ Deteriorated

Infiltration: ☐ None ☐ Joint ☐ Cracks ☒ **Mortar** ☐ Roots ☒ **Wall**

loose bricks

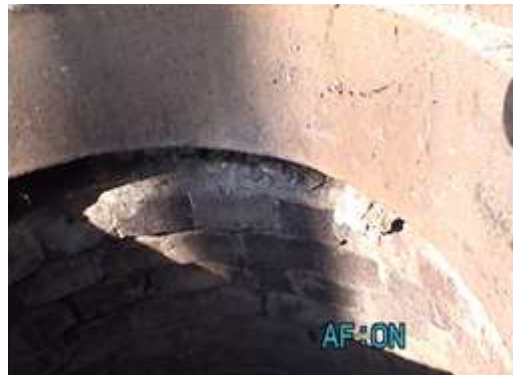
Defect 2

frame leaks

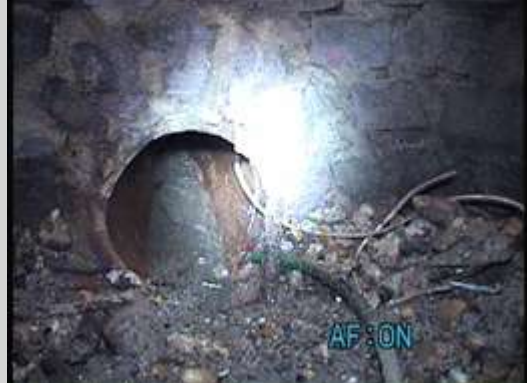
12 O'Clock Outflow

8 in. Circular Gravity Sewer
Pipe Out @ 12 O'Clock

Infiltration: **None** Pipe Seal Cond: **Sound**
